Damage to Concrete Piles in Buildings

Koushiro Nagai

Abstract

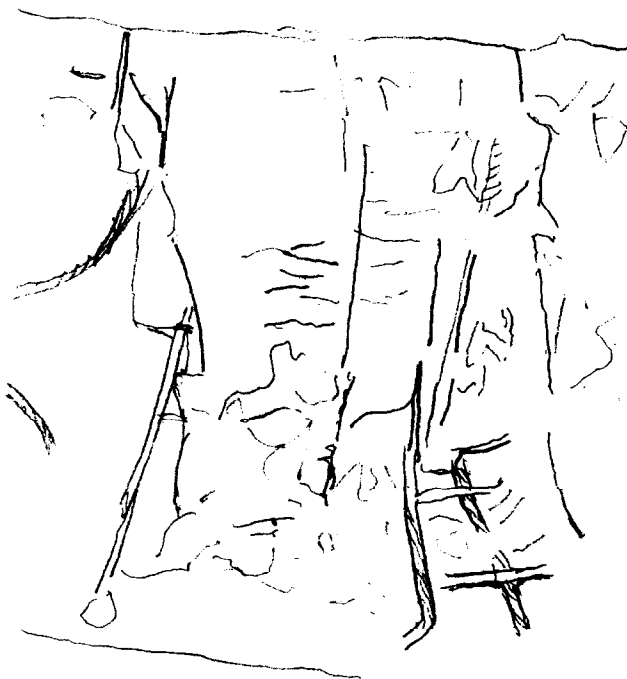
Fig. 7. Detail of Plate 1.

above photos, we can see the longitudinal fissures along the tension bars (in Fig. 7) and ones caused by the packed concrete (in Fig. 8), Plate 3 shows cracks in the pile cap in the north side.

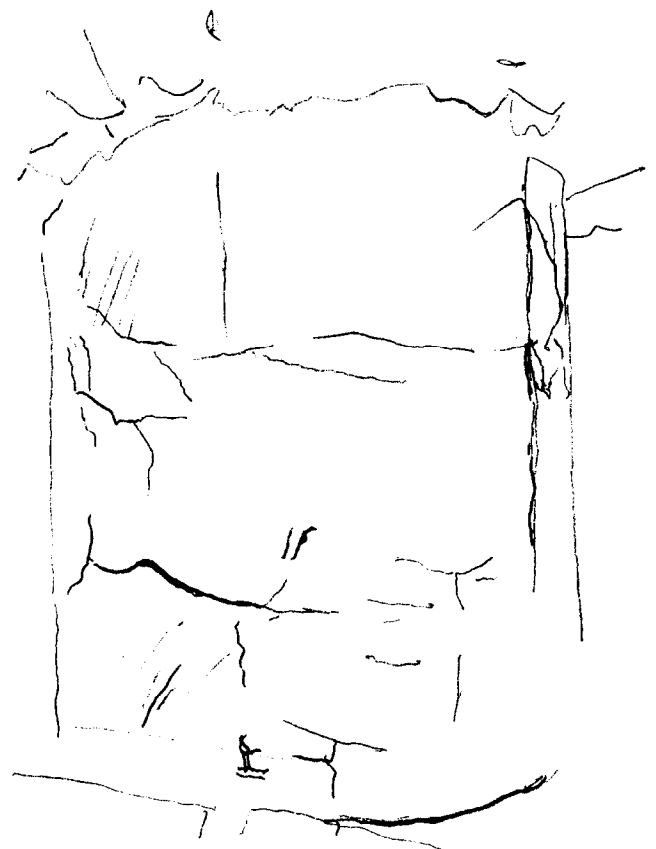
Fig. 8. Detail of Plate 2.
