INVESTIGATION OF DETERIORATED CONCRETE RAILWAY TIES

Some prestressed concrete ties placed on railway from Nanjing to Shanghai show map and longitudinal cracking. Up date to 1995, cracking happened in 9082 ties out of 20945 on 11.9 km railway in Shanghai and more than 85% ties were damaged at Shanghai railway station. Analyses on the affected concrete ties indicate that periclase and ettringite are not involved in the expansion of concrete. The coarse aggregates were alkali-silica reactive and were attacked by alkalis. Alkali-silica reaction is a primary cause for deterioration of the railway ties.

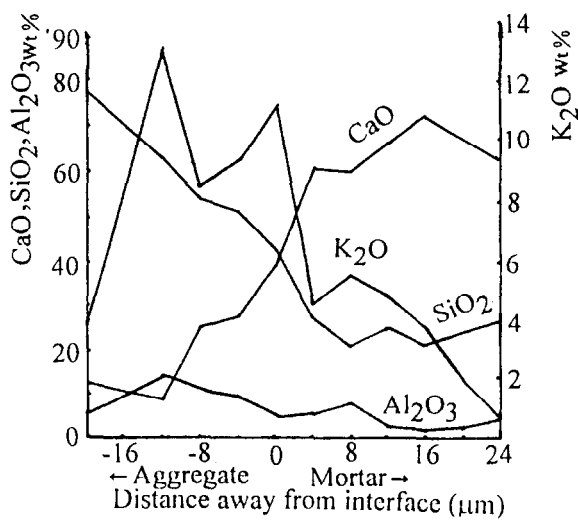
FIG. 6.
EDAX result of interface of cement and aggregate.

SEM/EDAX Analysis. New broken face of concrete ties was submitted to SEM/EDAX analysis. Fig. 4 reveals the morphology of interface of cement and coarse aggregate. A crack along with the interface was observed. The aggregate was attacked and eroded, accompanied by formation of gel-like product as shown in Fig. 5, which is enlarged from Fig. 4. DAX analysis shows that the aggregate is enriched in Si and the gel-like product is CaO-SiO₂ gel enriched in K (Fig. 6). Ca in the gel is smaller than that in CSH gel. This seems to indicate that the gel was produced by alkali-silica reaction.
