Damage to Concrete Piles in Buildings

Koushiro Nagai

Abstract

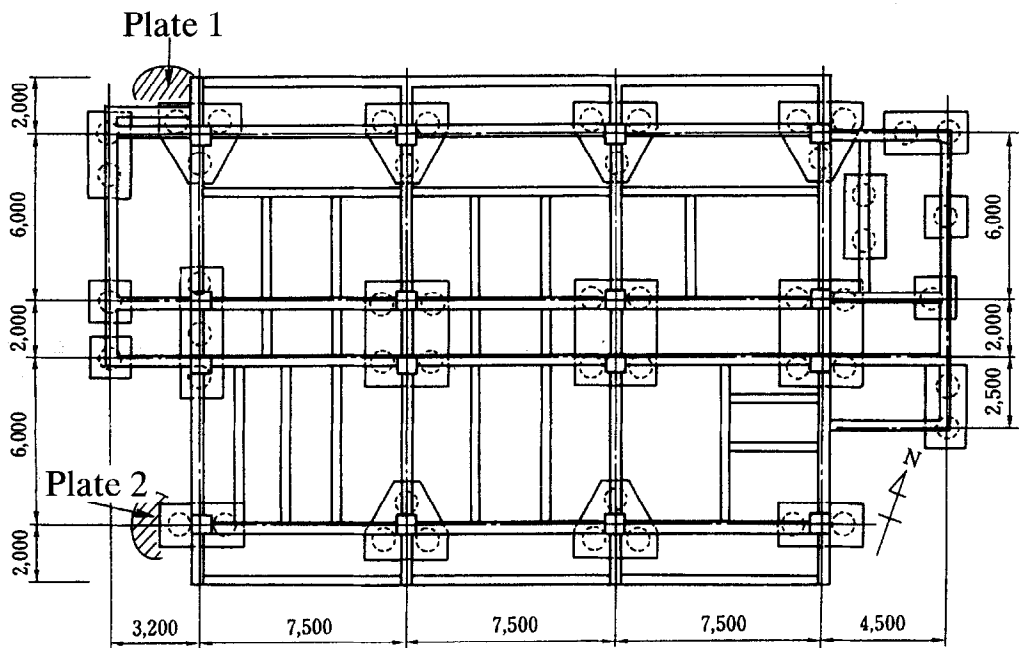
Fig. 4. Foundation plan.

Let us now examine the first of the detailed case studies. The high quality concrete piles with $F_c = 80 \sim 85$ MPa, $D = 0.6$ m and $L = 33$ m, supported the four-story reinforced concrete office building, the superstructure of which, remaining intact, tilted towards the sea (the north) by $1/70 \sim 1/75$. The site is located in the geological zone VI in Fig. 1. The foundation plan of the building is shown in Figs 4 and 5

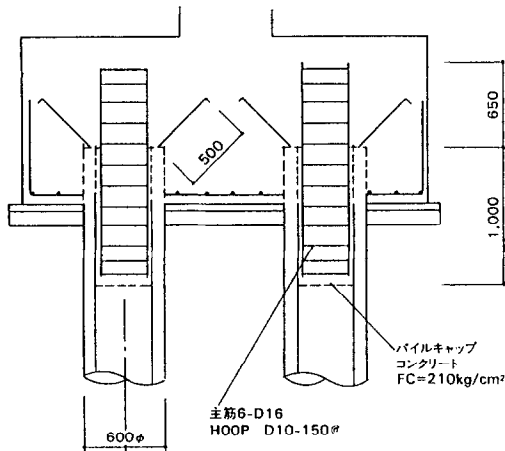
Fig. 5. Detail of connection between pile and pile cap.

The pile head dug out in the north side of the building had been compressed to failure and packed reinforced concrete (see Fig. 5) in the head appeared as shown in Plate 1. In the pile head in the south side, tension cracks were noticed as shown in Plate 2. In Figs 7 and 8 which show fissures or wrinkles, invisible in the

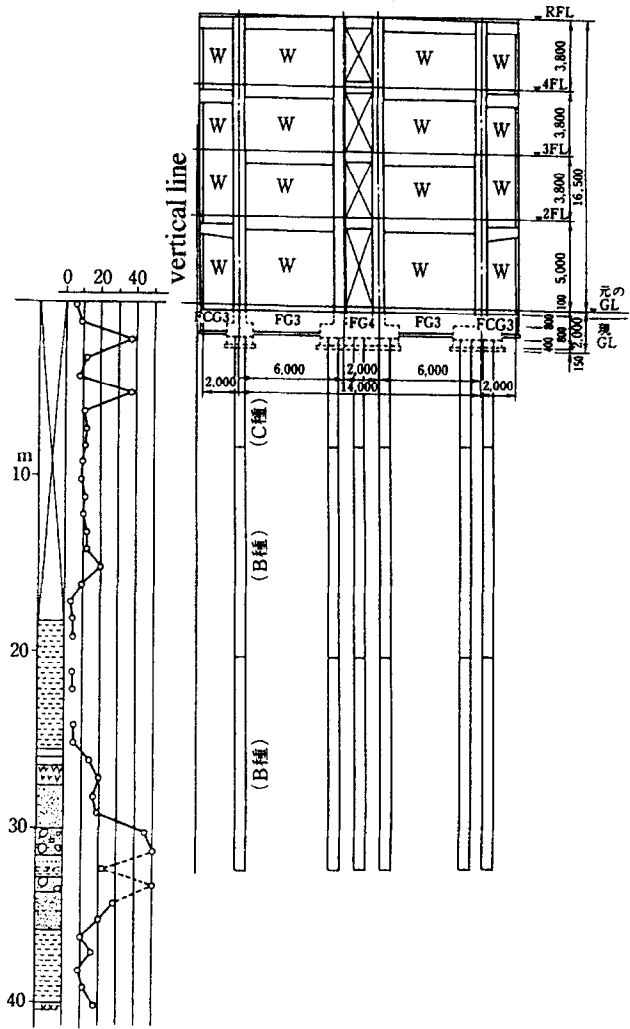
Fig. 6. Frame, piles and a boring log.

In Fig. 6, the frame which is tilted by $1/70$, piles which have inclination of $1/24$ (observed) and a boring log are shown. The pile has three segments. The upper segment is a 'Type C'

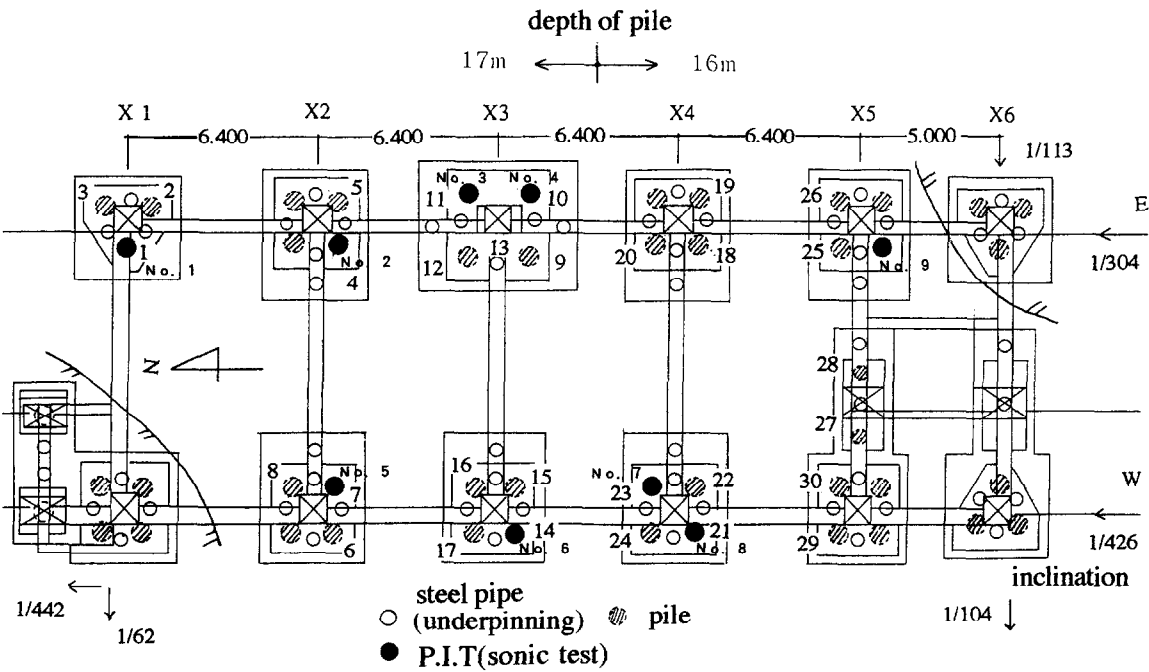
Fig. 9. Plan of pile foundations and values of building inclination.

The second detailed case study is given. The high quality concrete piles, $D = 0.6$ m, $L = 16 \sim 17$ m supported the nine-story steel encased reinforced concrete residential building. The site is located in the geological zone V-alluvial fan in Fig. 1. In this site, soil liquefaction was not observed. In Fig. 9, the plan of pile foundations and also the values of inclination of the building are shown. The building was inclined towards the west, remaining intact except that non-structural partitions were fissured.

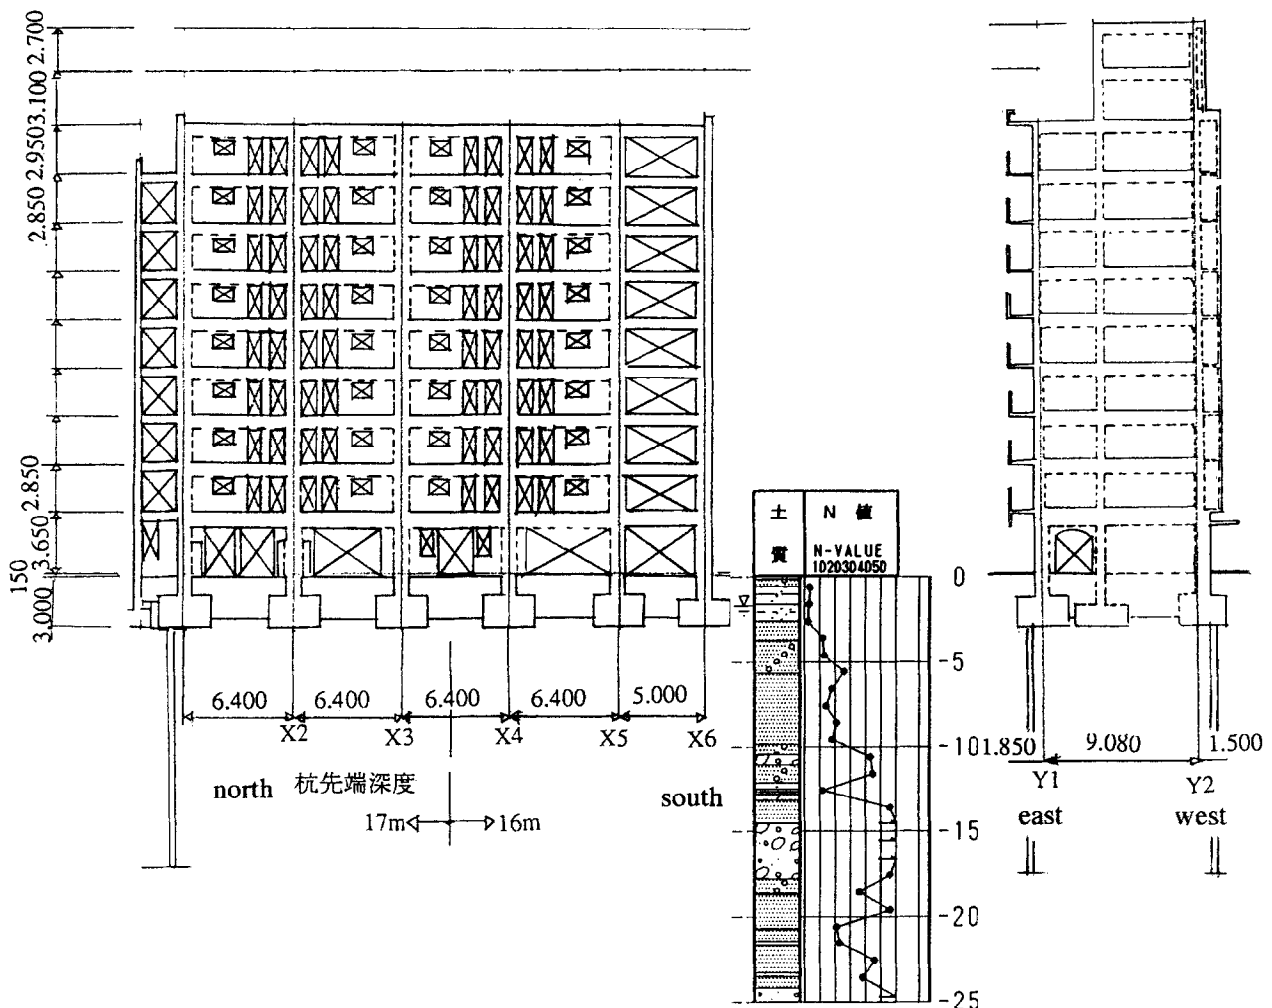
Fig. 10. Frame, pile and a boring log.

The sections of the building are shown in Fig. 10 with piles and a boring log. The aspect ratio in the east-west section is about three excluding penthouse height. The detail of the connection between pile head and pile cap is shown in Fig. 11. The pile has two segments. The upper, 9 m long, was a 'Type B' and the lower was a 'Type A', which was prestressed by 4 MPa. As the pile head had been cut off by 1.5 ~ 2 m, pressure did not exist corresponding to that of a 'Type B', 8 MPa.

above case we should assume that the concentration of inertia force in the west side pile caps resulted from the large axial force with subsidence caused by large overturning moment due to a high aspect ratio.

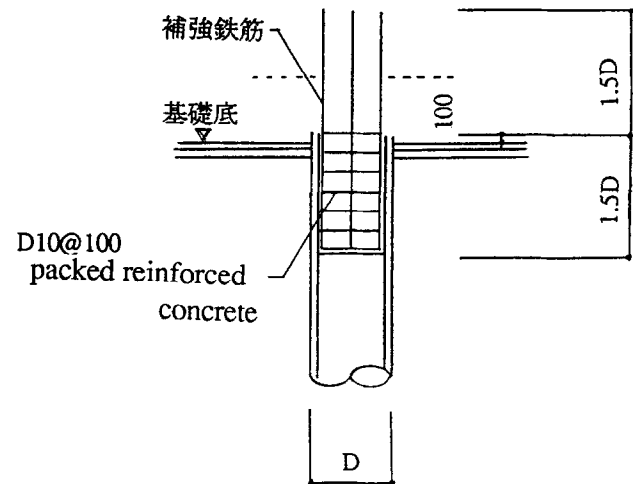
Fig. 11. Detail of connection between pile and pile cap.

One possible cause of the heavy damage to the piles is that pile heads, which were released from stress state, were easily torn and sheared by the packed reinforced concrete (see Fig. 11), but there is another, more important cause as follows.

Usually, these facts combine with the following conditions. The pile head and pile cap are connected loosely to each other as shown in the Fig. 11, because it is difficult that a pile head is well embedded in the pile cap owing to the existence of steel bars of the pile cap. If such a loose connection is compressed with great axial force, it will be fixed tightly. Therefore, in the

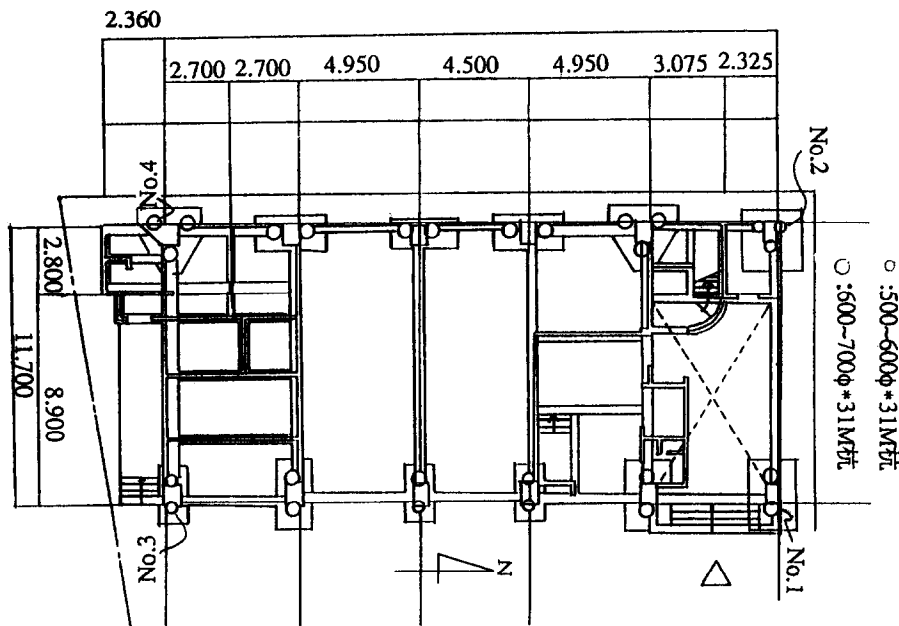
Fig. 14. Plan of pile foundation.

The plan of the pile foundation is shown in Fig. 14, piles of which are laid out according to the load carried from the column. The detail of connection between pile head and pile cap is shown in Fig. 15. The superstructure with pre-stressed precast concrete beams, remaining intact, tilted towards the north-east as shown in Fig. 16. The breakage in the figure at the lower end of steel pipe was surveyed by boring through the pile cap. Every pile that was dug out at the No. 1~4 of pile cap has an inclination of $1/23 \sim 1/30$ towards the west and of $1/60$ north. These directions correspond to the movement of the ground surface. A pile head is shown in Plate 11 in which the concrete of a pile cap was torn and then dropped, leaving steel bar for installation exposed. It is assumed that the breakage resulted from the movement of soil surface due to soil liquefaction.

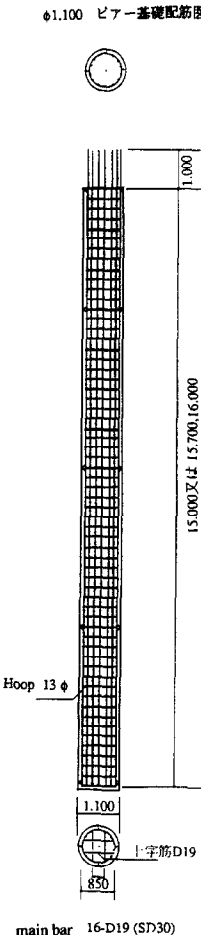
Fig. 19. Steel bar arrangement in the pile.

Figures 17 and 18 show, respectively, the section and plan of the building. In Fig. 19, the elevation and a section of the steel bar arrangement in the pile are shown. A pile was cored down to a depth of 12.4 m from the first basement floor and a television observation was made. Plates 12 and 13 show that several horizontal cracks appeared at a depth of about 10 m as well as near the pile heads. This suggests that the alluvial deposit down to a depth of about 10 m might have liquefied and slid leading to the failure of piles. It was noticed that the ground water flowed into the bored hole through the fissures.

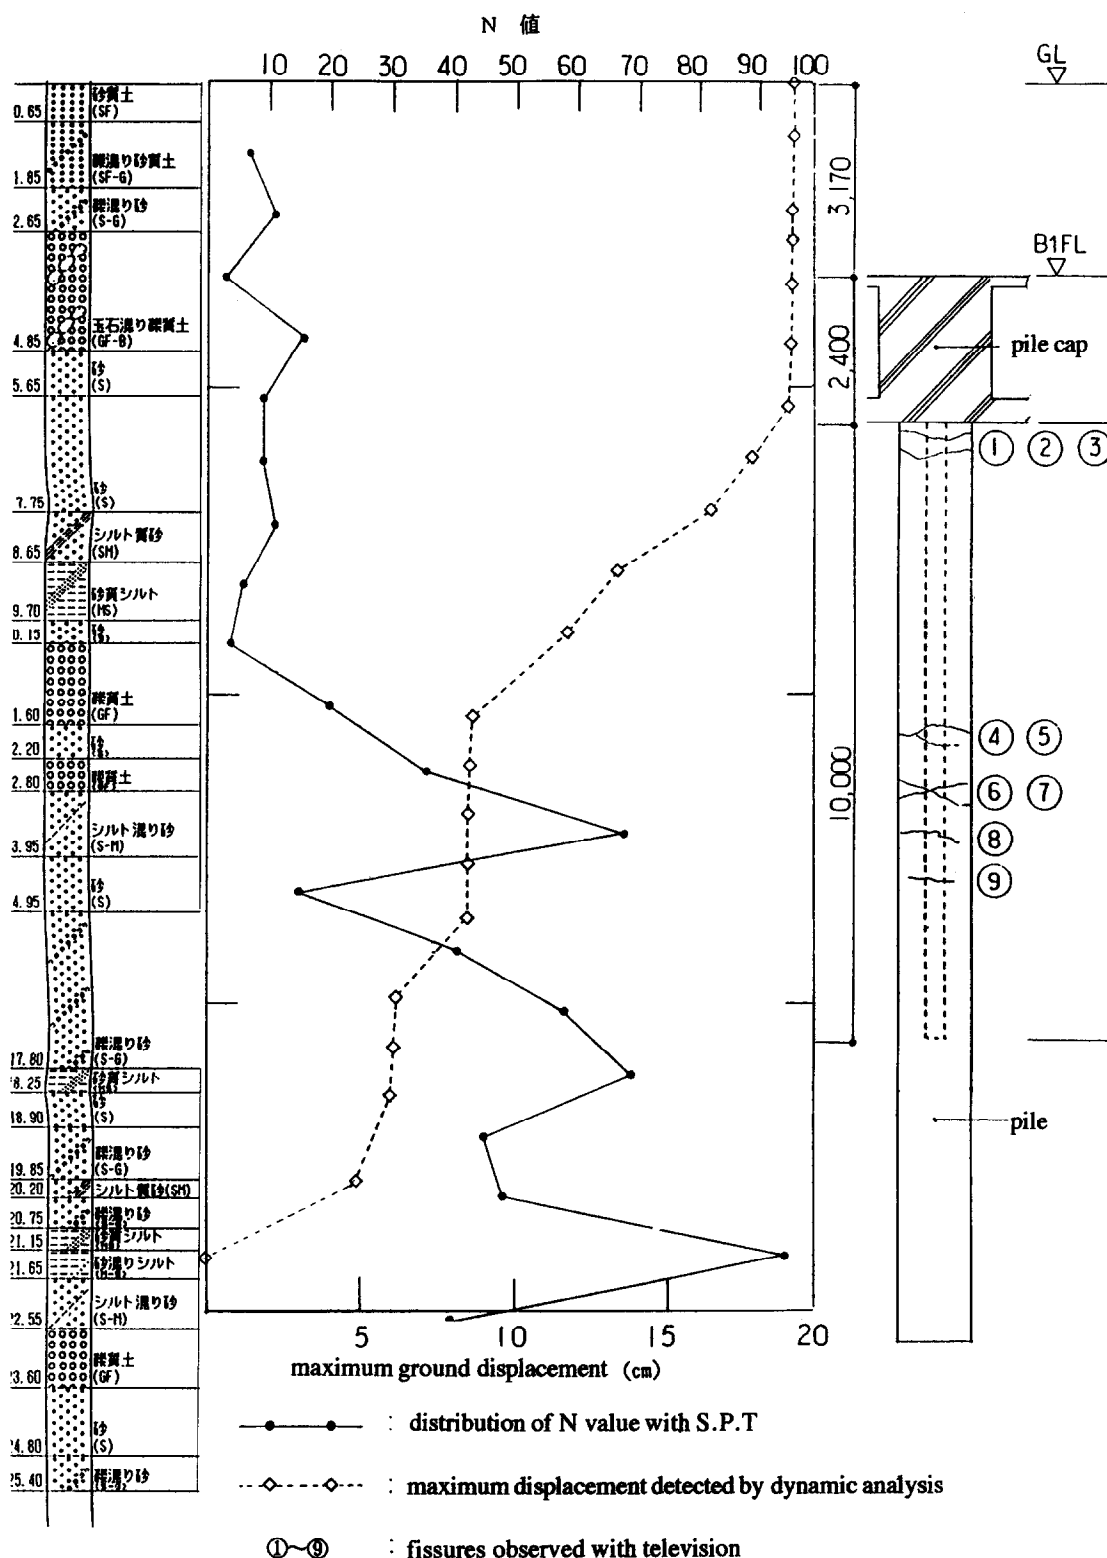
Fig. 20. Analyzed lateral maximum displacement and a boring log.

nonlinear effective stress analysis. Large relative displacement between the head and middle height is 1/50 and the portion of the middle height of the pile, in which fissures of no. 4~9 were found, is not displaced relatively. Accord-

ing to the result, the maximum bending moment appeared at the middle height; it is unclear whether only the repeated bending moment caused the fissures which reach to the center of the pile without force being sufficient

to be sheared or stretched. It would become clear if the fissured portion could be dug out.
