Performance evaluation of repair systems under varying exposure conditions

M. Maslehuddin ^{a,*}, S.H. Alidi ^b, M. Mehthel ^b, M. Shameem ^a, M. Ibrahim ^a

^a Centre for Engineering Research, Research Institute, King Fahd University of Petroleum and Minerals, Dhahran 31261, Saudi Arabia

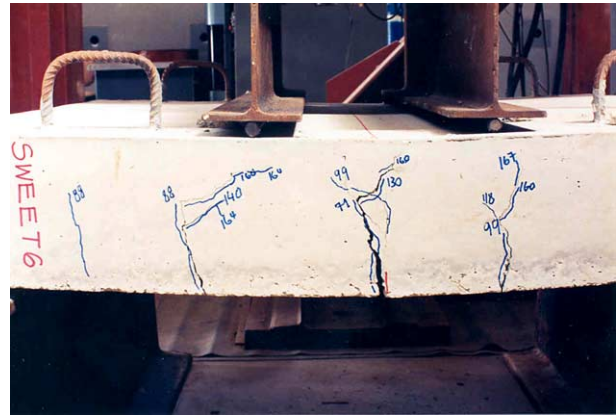
Fig. 4. Close-up view of a cracked concrete specimen.

Figs. 3–5 show the setup utilized for inducing cracks, a close-up view of a cracked specimen and the process of repairing a cracked concrete specimen, respectively.

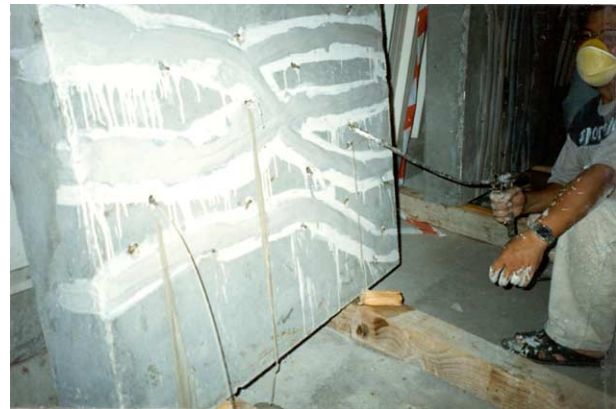
Fig. 5. Repair of cracks in the slab specimens by epoxy injection.

The cracked specimens were repaired by using system 9 (epoxy injection material) and system 10 (polyurethane-based injection material). For the purpose of injecting the repair material, several nipples were inserted into the crack and the remaining length of the crack was sealed with putty. The repair material was then injected into the crack, starting from the lower nipple until it oozed out from the upper nipple. This process was continued until the entire crack was filled with the injection material.

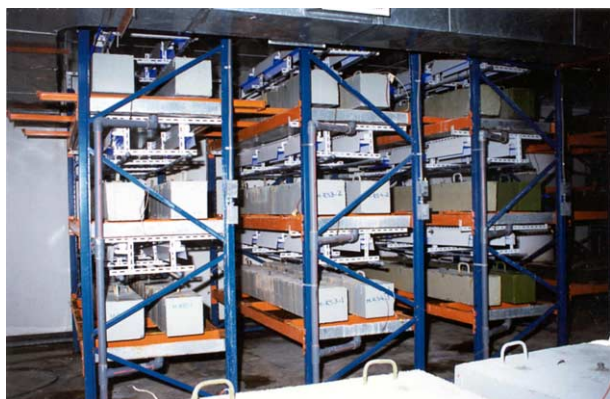
Fig. 6. Concrete beam specimens exposed to salt spray and UV light (marine exposure).

In this category, the repaired (systems 1, 2, 3, 4, and 7) and control concrete specimens were placed on three racks and exposed to salt spray, thermal cycling, and UV light. Sodium chloride (5%) solution was sprayed on the concrete specimens through an automated salt spray system. The salt solution was sprayed on the top of the concrete specimens every 2 h for 5 min. Fig. 6 shows the arrangement of the concrete specimens along with the salt spray system and UV lamps.

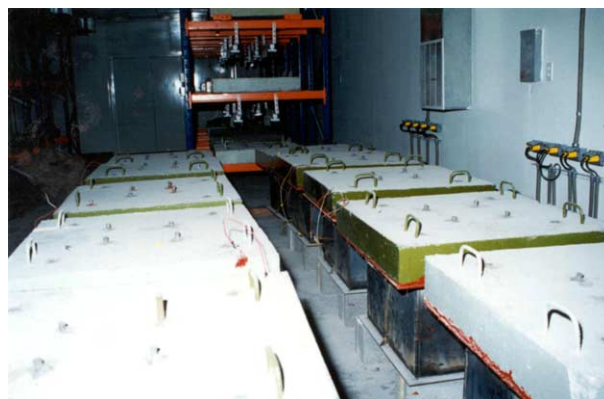
Fig. 7. Concrete slab specimens exposed to sulfur fumes.

The repaired and control concrete specimens in this category were exposed to sulfur fume and thermal cycling. The repaired face, measuring 0.5×0.5 m, was exposed to the sulfur fumes. For this purpose, each of the concrete specimen was placed on a metallic tank filled with sulfur to three quarter of its depth. The bottom of the tank was heated using electric heaters to keep the sulfur in a molten form. Fig. 7 shows the arrangement utilized to expose the concrete specimens to sulfur fumes.

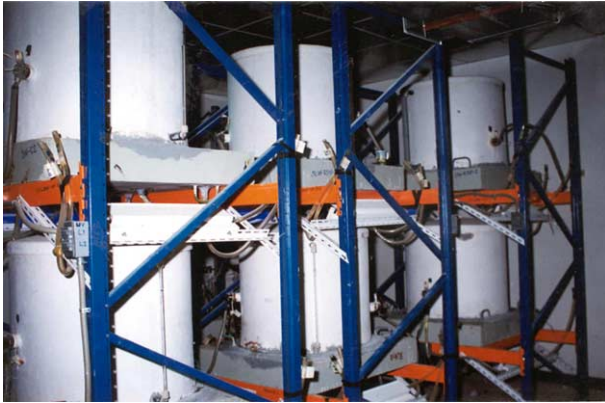
Fig. 8. Repaired and control slab specimens exposed to potable and saline water.

The repaired face was exposed to thermal variations and UV exposure. For UV exposure, two UV lamps were fixed below the unrepaired face of the specimen. Fig. 8 shows the repaired and control concrete specimens exposed to potable and saline water.

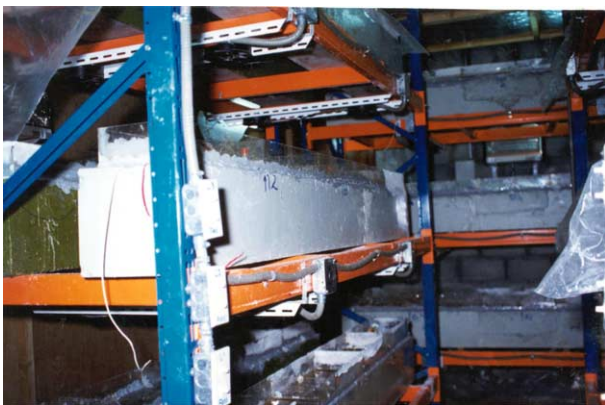
Fig. 9. Control and repaired concrete beam specimens exposed to belowground conditions.

This exposure is representative of the belowground conditions in a hot and aggressive climate. In such situations the sub-structural components are exposed to groundwater with high salinity and a temperature of 40 °C. Eighteen reinforced concrete beam specimens were placed on three exposure racks and exposed to a constant temperature of 40 °C, while a mixed chloride (15% Cl^-) and sulfate (2.1% SO_3) solution was ponded on the repaired face. Plexiglas frames were fixed on the concrete specimens in order to retain the chloride–sulfate solution. Air circulating fans were fixed on the bottom of the specimen to force evaporation of the salt solution from below. Fig. 9 shows the concrete specimens exposed to below ground conditions, i.e. chloride–sulfate solution at 40 °C.

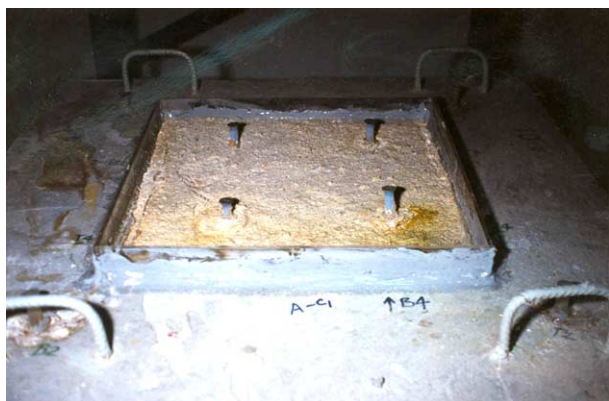
Fig. 10. Control concrete specimens exposed to sulfuric acid.

Figs. 10–13 show the control and repaired concrete specimens after exposure to sulfuric acid for eight months. Significant concrete deterioration was noted in the control concrete specimens while enhanced deterioration of the coating and the repair material was noted in the concrete specimens repaired with repair system 5. Only coating deterioration was noted on the concrete specimens repaired with repair system 8. Minimal deterioration was noted on the concrete specimens repaired with repair system 6. The adhesion values were in the range of 1.6–2.3 MPa.

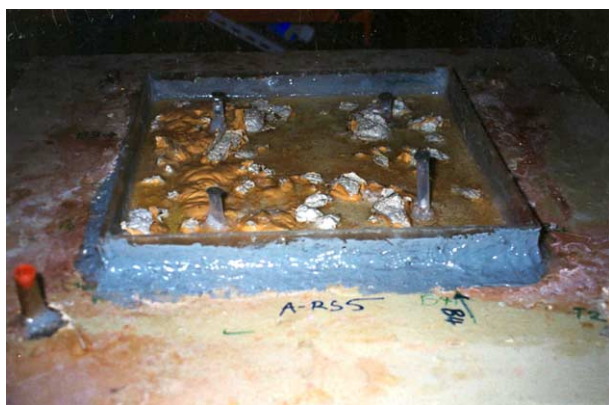
Fig. 11. Concrete specimens repaired with system 5 and exposed to sulfuric acid.

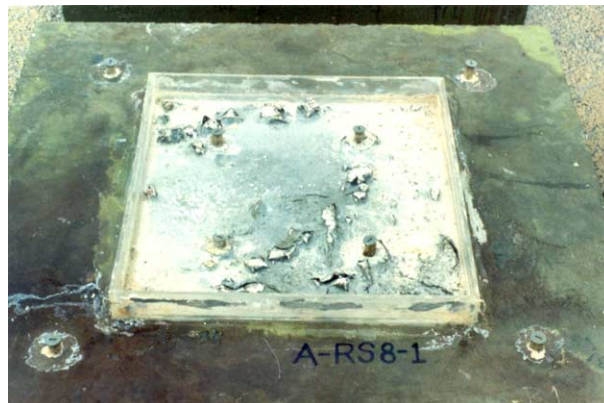
Fig. 12. Concrete specimens repaired with system 8 and exposed to sulfuric acid.
